Window nV & nVII

nV Window removed 11th November 2008.

nVII Window removed 15th October 2008.

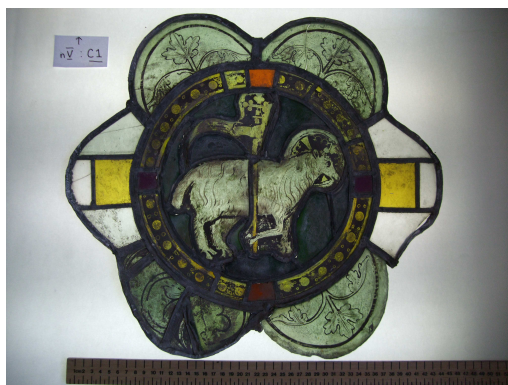
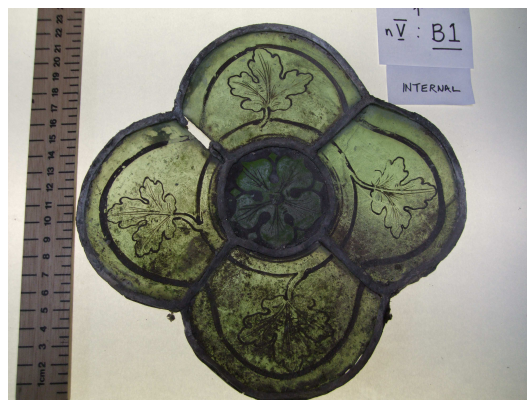
The carefully removal of the main lancets and ancient glass to tracery panels, temporary secure boarding fitted. Safely crated and transported to our studio

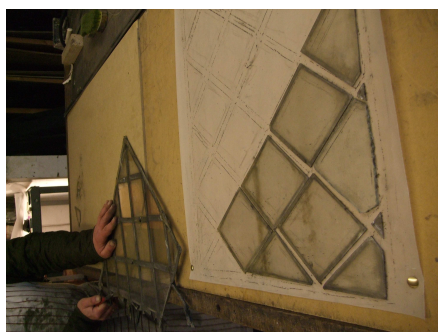
At our studio all the ancient glass tracery panels were photographed in reflected and transmitted light – which provided an accurate recording of the condition of the glass.

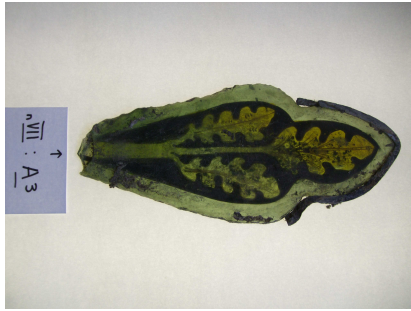
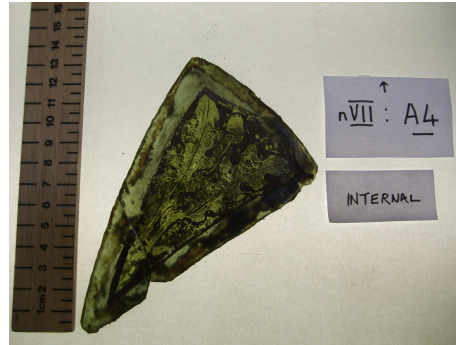
Before during and after conservation a full photographic record of each tracery panel was taken in reflected and transmitted light. This documentation provides details of any cracks or holes in the glass, the lead types and sizes, previous restoration insertions, the painted detail and any other interesting marks and symbols condition of each panel thoroughly examined to assess the stability of the paint, the build up of microorganisms etc using a microscope.

Each panel recorded and rubbings taken.

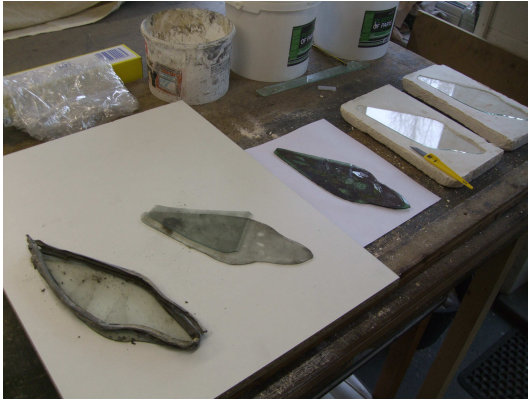
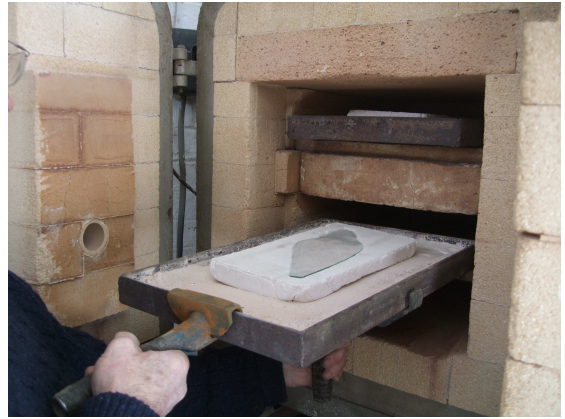
Broken fragments conserved with grade epoxy-resin (Araldite 2020) or an acrylic

resin (Paraloid B-72).

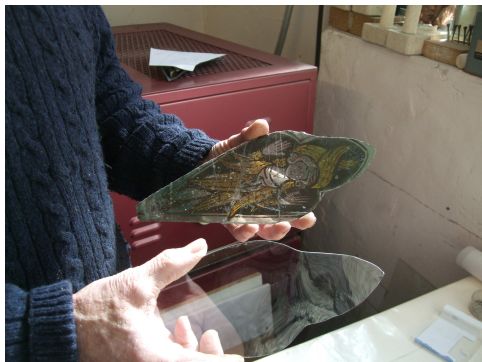
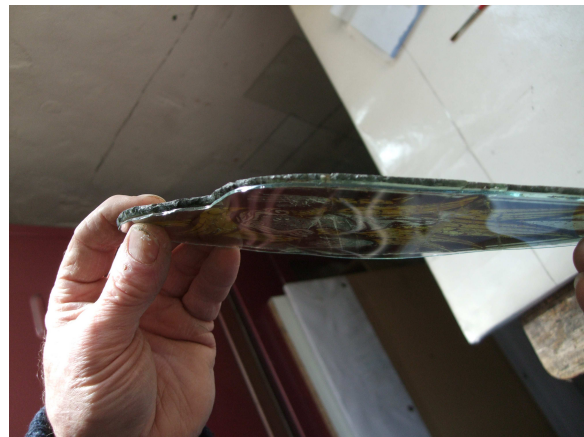
Plaster cast mould taken to shape of glass fragments which required plating to strengthen glass and assist repaired cracks.

Glass cut to size and heated in kiln to slump into undulation of original glass fragments with 1.2mm plating glass. This strengthens fragile pieces of glass and assists in the repair of many cracks.

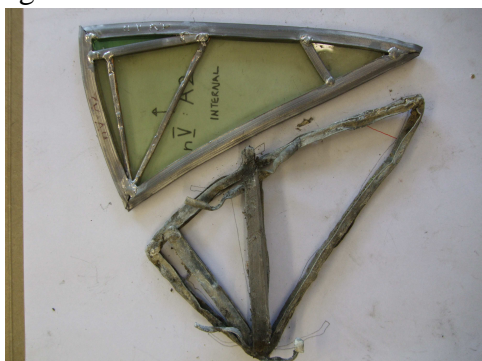
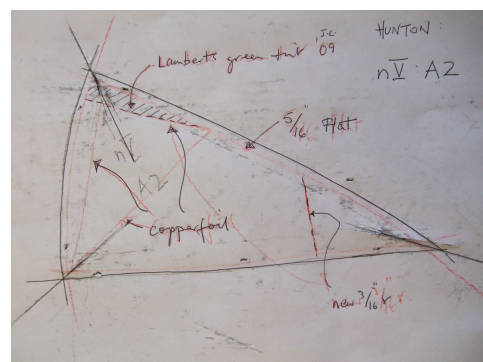
- glass is cut to the same shape of the fragile piece and a conservation grade silicone used to seal the edges to ensure prevention of moisture into interspaces.

To consolidate the unstable pigment with the use of a solution of a resin with a hardener, such as an acrylic resin (Paraloid B-72) this film remains unchanged with age.

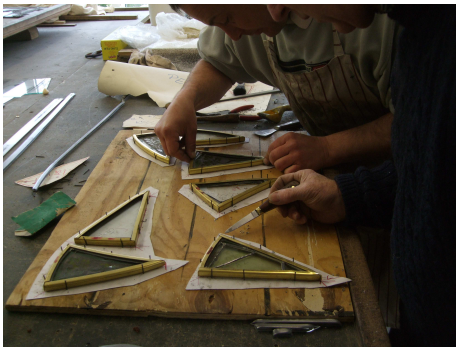
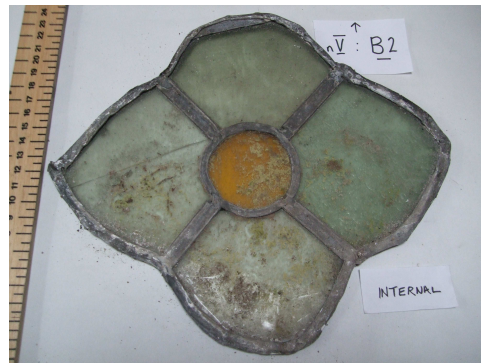
To manufacture and fit internally Manganese brass frames (isothermal) to accommodate the medieval panels and modern replacements (for continuity) formed to sight size of the stonework and fixed as required by stainless steel screws. The

tracery
glass
panel

inserted into the frame and retained by a formed bead (material as external frame). external glazing or internal frame. I.e. remove beading and panel for close inspection

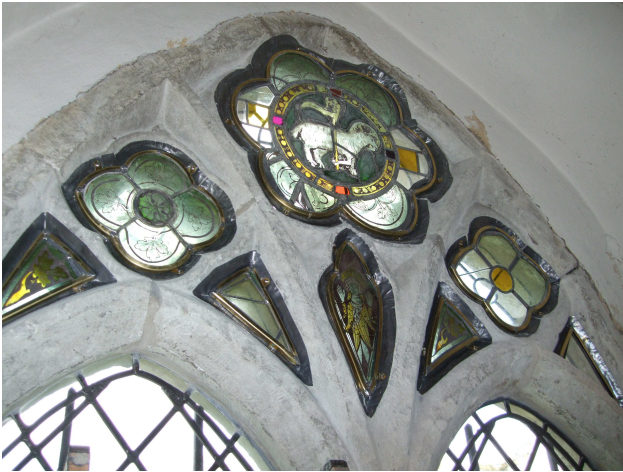
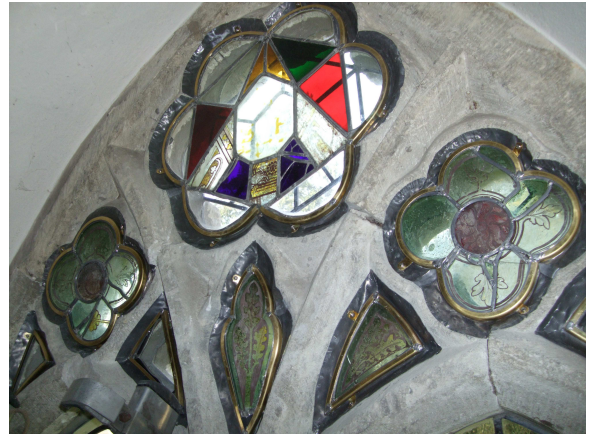
To fit the isothermal frames to the inner edge of the stonework and glaze with restored tracery panels.
